# Tree Condition Assessment

Barnwood Close, Guildford, GU2 8GG

Reference: MW.2503.BCG.TCA  
Client: [REDACTED] Landscapes Ltd  
Date: 19 March 2025

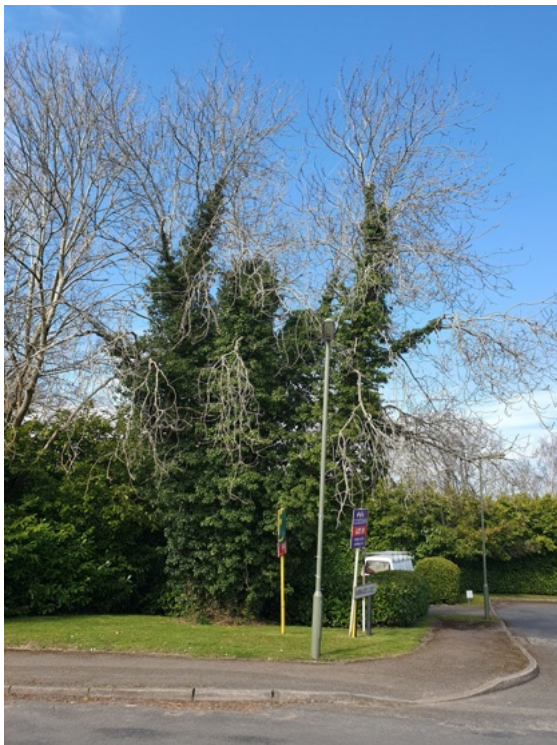
01 P001

| Ref | Species | Stem Diameter (est cm) | Height (est m) | Survey Notes | Recommendations* | What3Words** | Priority |
|---|---|---|---|---|---|---|---|
| 01 | Common ash | 40 | 12 | Multi-stemmed tree on the grass verge. Ivy is becoming very dominant. No obvious signs of dieback | Sever ivy at base | ///gifts.mixed.trip | Medium |

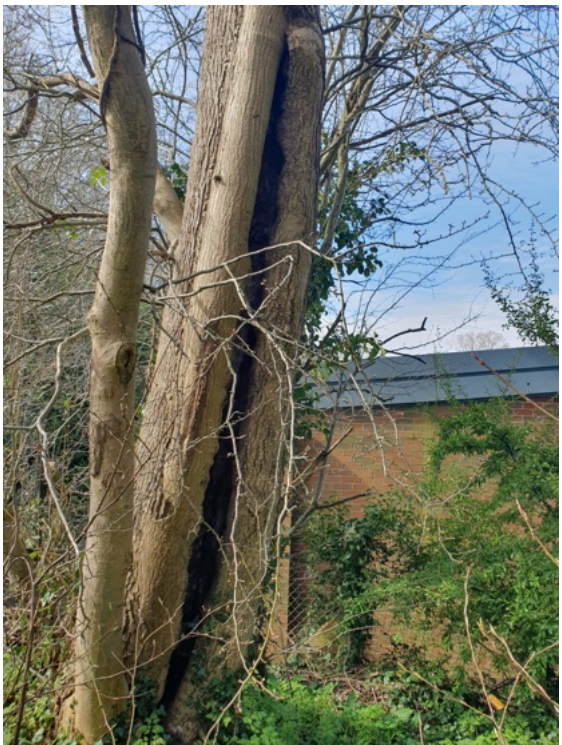
03 P001

| Ref | Species | Stem Diameter (est cm) | Height (est m) | Survey Notes | Recommendations* | What3Words** | Priority |
|---|---|---|---|---|---|---|---|
| 03 | Common ash | 60 | 15 | Signs of ash dieback. Significant longitudinal hollow in the main stem. Over adjacent commercial premises | Remove tree | ///wizard.bench.filer | Medium |

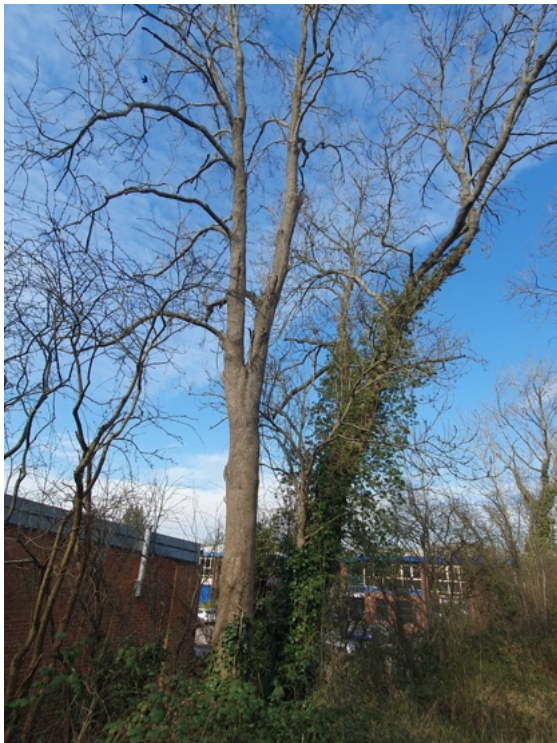
04 P001

| Ref | Species | Stem Diameter (est cm) | Height (est m) | Survey Notes | Recommendations* | What3Words** | Priority |
|---|---|---|---|---|---|---|---|
| 04 | Common ash | 45 | 17 | One of two stems with die back. Over adjacent commercial premises. Stem has anomalous bark at approximately 7 m consistent with internal decay. | Remove tree | ///jacket.names.path | Medium |

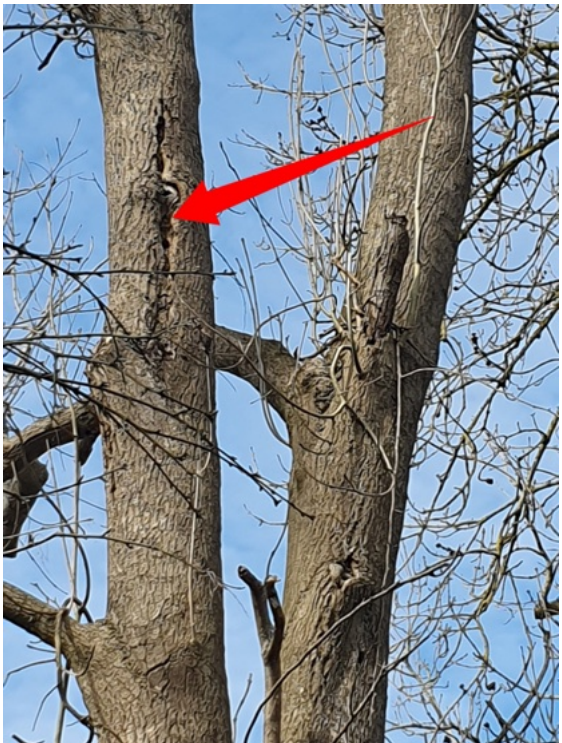
04 P002 Potential decay point

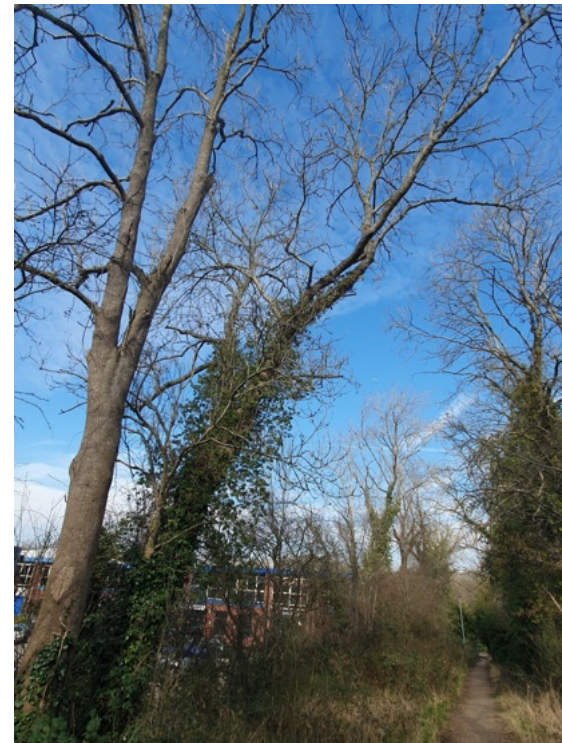
05 P001

| Ref | Species | Stem Diameter (est cm) | Height (est m) | Survey Notes | Recommendations* | What3Words** | Priority |
|---|---|---|---|---|---|---|---|
| 05 | Common ash | 45 | 17 | One of two stems with die back. Ivy on stem. Leaning north east over path and adjacent parking area | Remove tree | ///jacket.names.path | Medium |

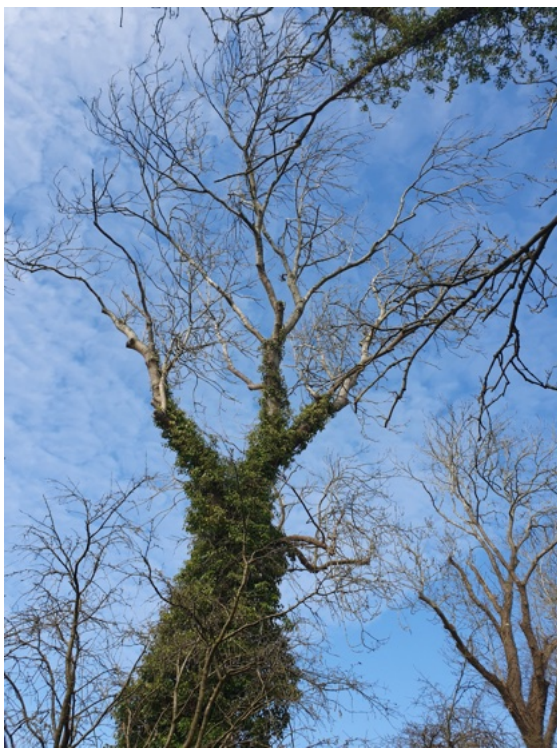
06 P001

| Ref | Species | Stem Diameter (est cm) | Height (est m) | Survey Notes | Recommendations* | What3Words** | Priority |
|---|---|---|---|---|---|---|---|
| 06 | Common ash | 60 | 18 | Ash dieback. Adjacent to commercial premises | Remove tree | ///tooth.bowls.open | Medium |

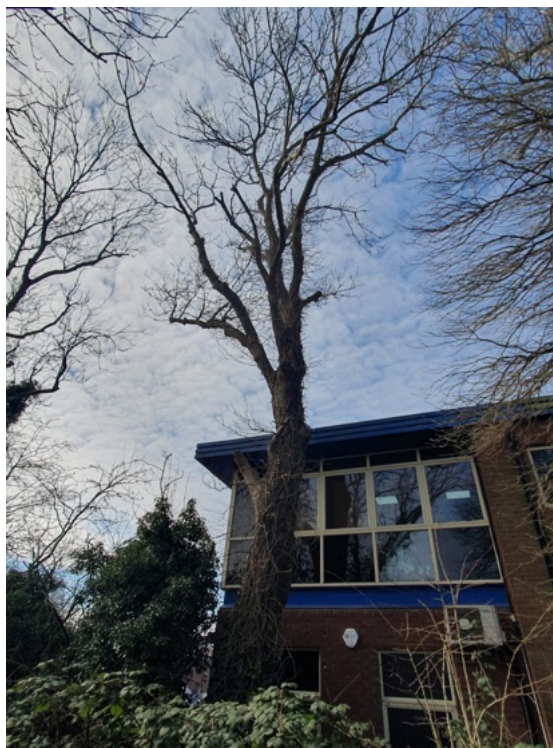
07 P001

| Ref | Species | Stem Diameter (est cm) | Height (est m) | Survey Notes | Recommendations* | What3Words** | Priority |
|---|---|---|---|---|---|---|---|
| 07 | Common ash | 60 | 18 | Ash dieback. Adjacent to commercial premises | Remove tree | ///pills.cigar.work | Medium |

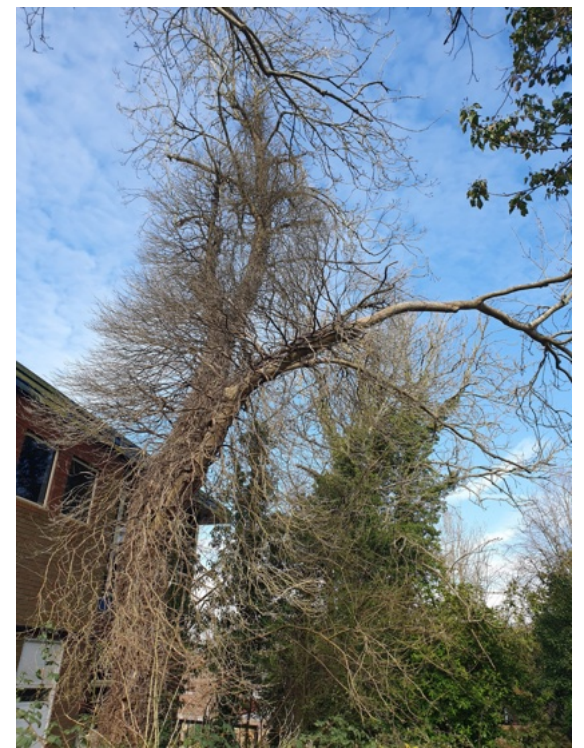
08 P001

| Ref | Species | Stem Diameter (est cm) | Height (est m) | Survey Notes | Recommendations* | What3Words** | Priority |
|---|---|---|---|---|---|---|---|
| 08 | Common ash | 60 | 15 | Ash dieback. Adjacent to commercial premises | Remove tree | ///limbs.grant.pirate | Medium |

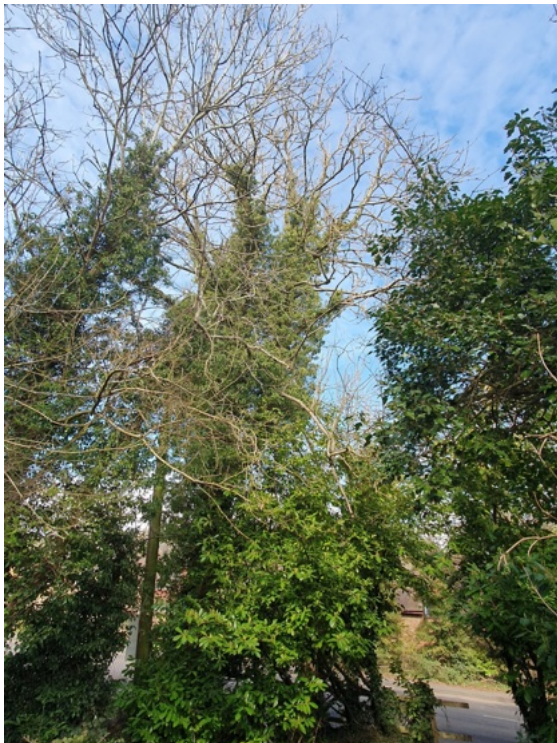
09 P001

| Ref | Species | Stem Diameter (est cm) | Height (est m) | Survey Notes | Recommendations* | What3Words** | Priority |
|---|---|---|---|---|---|---|---|
| 09 | Common ash | 60 | 16 | Ash dieback. Adjacent to commercial premises and highway | Remove tree | ///points.foil.rang | Medium |

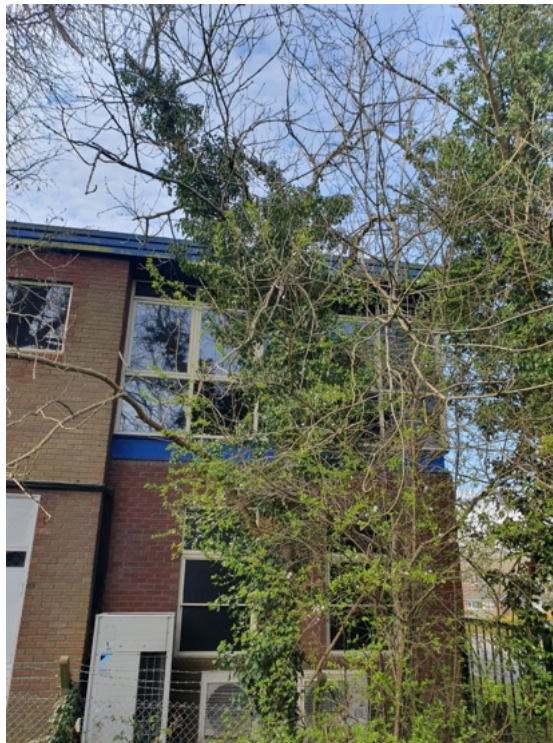
11 P001

| Ref | Species | Stem Diameter (est cm) | Height (est m) | Survey Notes | Recommendations* | What3Words** | Priority |
|---|---|---|---|---|---|---|---|
| 11 | Common ash | 25 | 8 | Smaller tree but still with die back. Dense ivy | Remove tree | ///sudden.full.atoms | Medium |

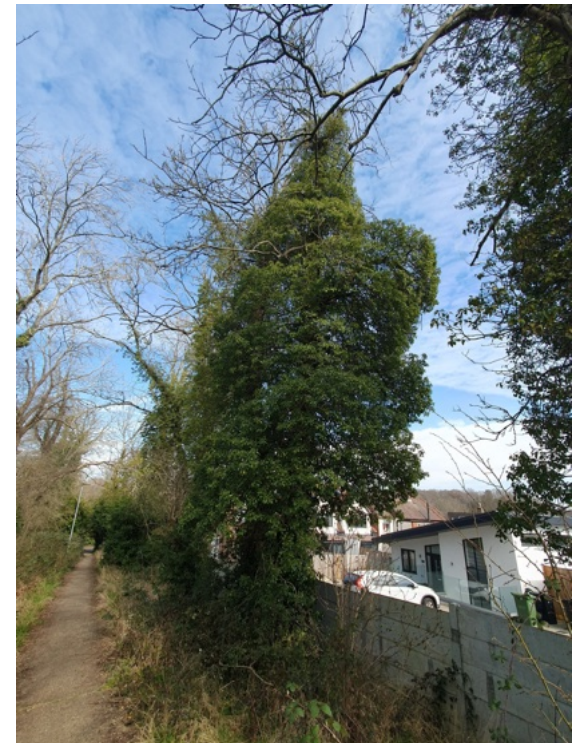
16 P001

| Ref | Species | Stem Diameter (est cm) | Height (est m) | Survey Notes | Recommendations* | What3Words** | Priority |
|---|---|---|---|---|---|---|---|
| 16 | Common ash | 40 | 14 | Ash dieback. Adjacent to recent residential development. | Remove tree | ///chained.breed.prefer | Medium |

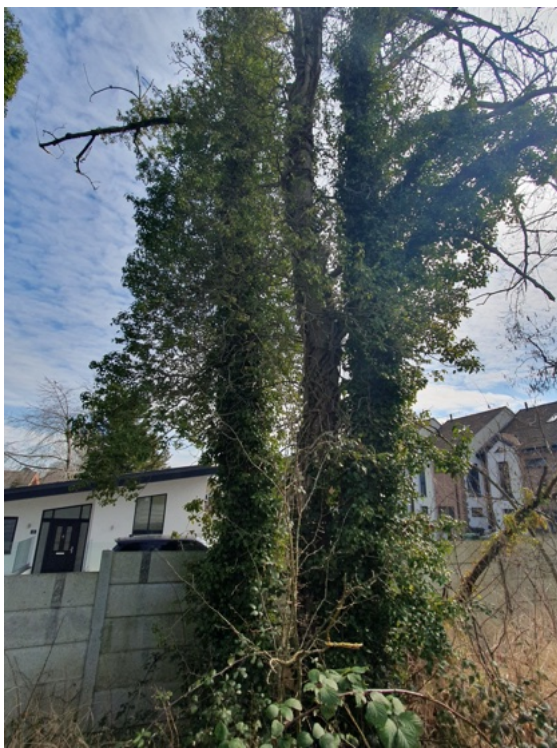
17 P001

| Ref | Species | Stem Diameter (est cm) | Height (est m) | Survey Notes | Recommendations* | What3Words** | Priority |
|---|---|---|---|---|---|---|---|
| 17 | Common ash | 40 | 16 | Ash dieback. Group of three stems. Adjacent to recent residential development. | Remove tree | ///worker.flash.kicks | Medium |

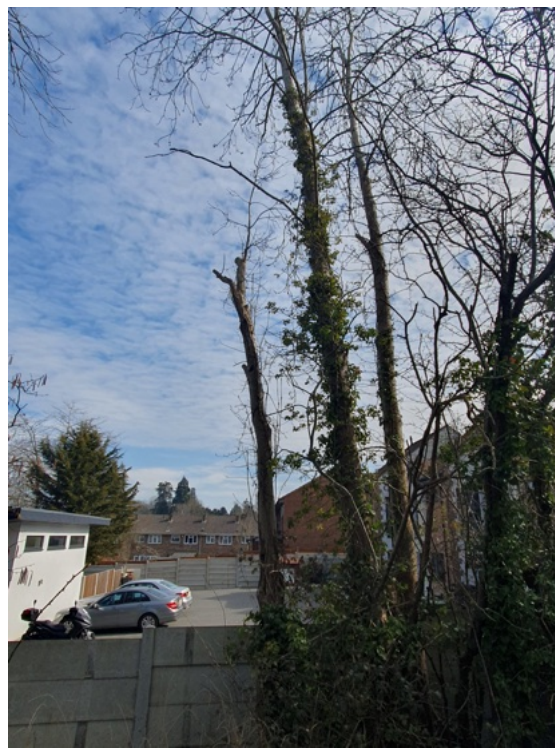
18 P001

| Ref | Species | Stem Diameter (est cm) | Height (est m) | Survey Notes | Recommendations* | What3Words** | Priority |
|---|---|---|---|---|---|---|---|
| 18 | Common ash | 25 | 13 | Group of three stems leaning over parking area. Touching new boundary wall. Limited signs of dieback but expected to decline. | Remove all three stems | ///palm.spell.format | Medium |

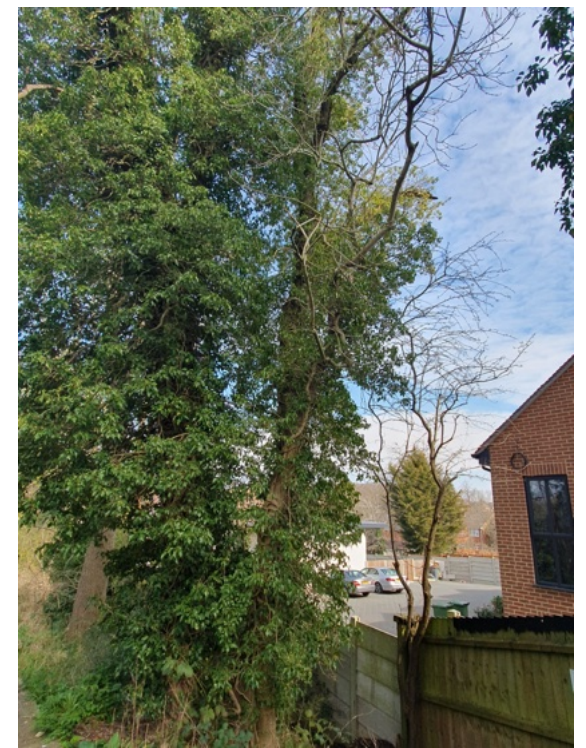
20 P001

| Ref | Species | Stem Diameter (est cm) | Height (est m) | Survey Notes | Recommendations* | What3Words** | Priority |
|---|---|---|---|---|---|---|---|
| 20 | Common ash | 40 | 16 | Ash dieback. Two stems. Ivy. Adjacent to recent residential development. | Remove tree | ///marker.thinks.lined | Medium |

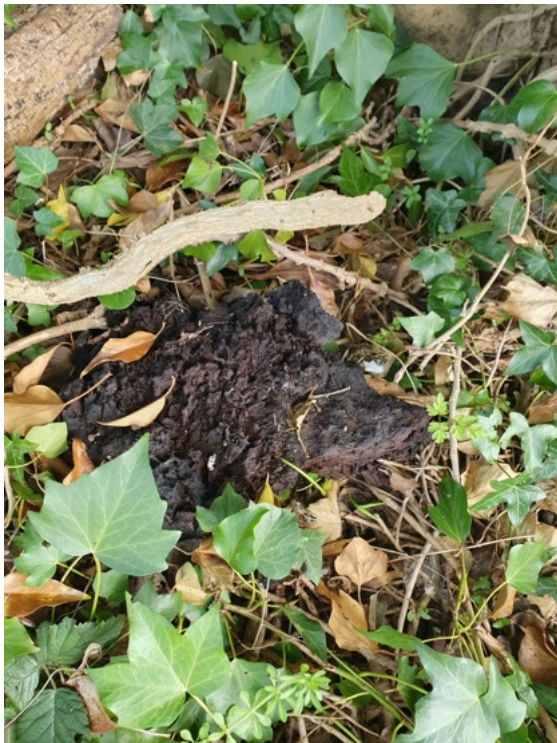
21 P001

| Ref | Species | Stem Diameter (est cm) | Height (est m) | Survey Notes | Recommendations* | What3Words** | Priority |
|---|---|---|---|---|---|---|---|
| 21 | Common ash | 50 | 14 | Ash dieback. Two stems. Ivy. Adjacent to recent residential development. Old fungal fruiting body on the floor consistent with Inonotus hispidus. The origin point of the final fruiting body is not visible due to dense ivy. Stems weighted towards the adjacent dwelling | Remove tree | ///blast.filed.skirt | Medium |
